Cushcraft R5 $\frac{1}{2}$ λ Vertical Maintenance and Repair

CUSHCRAFT R5 (10/12/15/17/20 m)

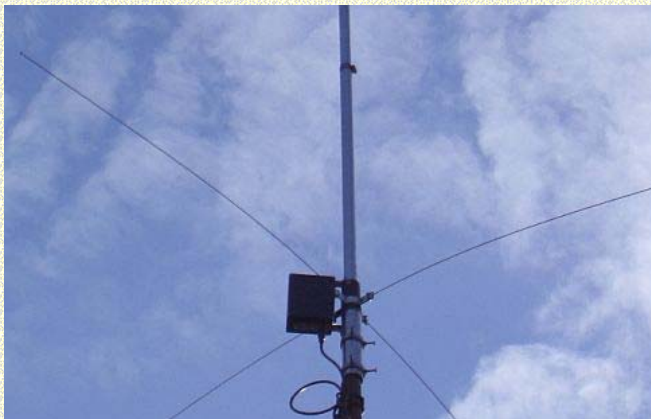
This antenna is very usable and, being asymmetrically fed, with no radials and only 4×1.24 m stainless steel whips («fig) is attractive for apartment dwellers. All hardware is aluminium or stainless steel. The aluminium durability is good but not as good as Fritzel's tubing. It has withstood many heavy windstorms without a problem and currently is bent over at about a 10 – 15 degree angle. It is rugged and not too tall mounting without guy ropes. This antenna is sensitive to metal objects in near field. Prevent installation over a metal roof or near out other antennas because they will detune the R5 considerably.

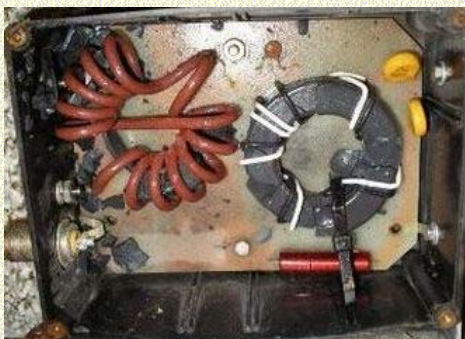
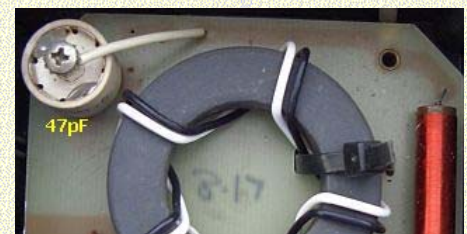
This happens if one use the antenna with an ATU and a lot of power on more than the specified 5 bands!

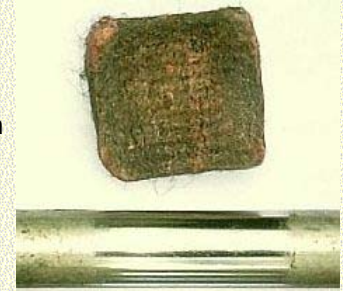
The traps should be carefully loosened and the contact area and all other aluminium hardware should be cleaned with Brillo pads (steel wool impregnated with soap).

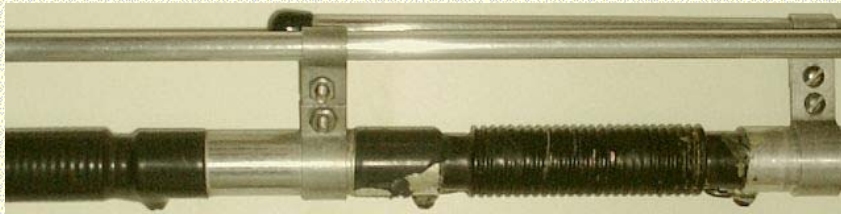
Water got inside a trap due to cracked heath shrink tubing.

I have been using my 2ndhand R5 for more than two years and then some problems arose. The SWR was varying and increased on some bands. I took the antenna down and it turns out that water got inside a trap because cracked heath shrink tubing and a split in the joint between the coil former (force-fit?) into the aluminium tube. The heath shrink tubing was carefully removed and the coil, covered with "transparent contact adhesive", was cleaned with thinner.

Once clean, the split should be filled with epoxy glue (2-part polyurethane adhesive), the coil buttered with transparent contact adhesive and reassembled with heath shrink tubing. The process with the transparent

adhesive is for preventing that water gets inside the trap.

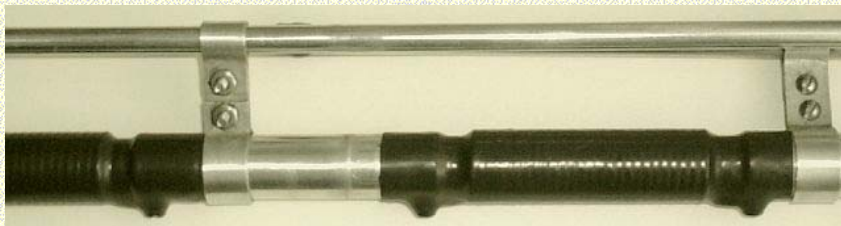
Cleaned and repaired coil

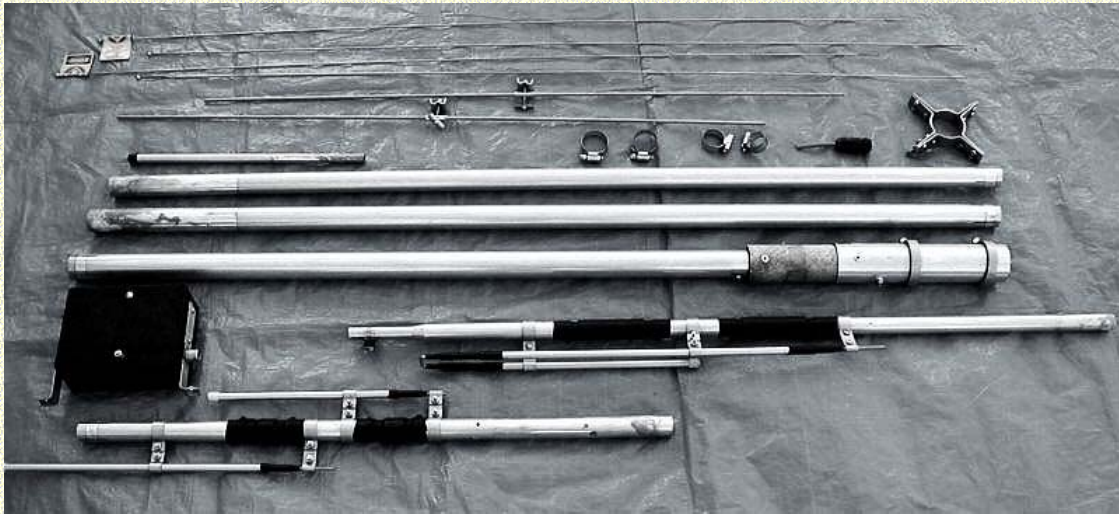
All R5 parts of the 1989 model.

Measuring the traps is only possible by comparison with another R5. Make sure that you do not touch any part of the antenna and vary the frequency of a (grid)dipper meter until a strong dip is seen. Move the meter away while retuning until a very shallow dip is seen. Take note of the trap frequency. Repeat this process with the repaired R5.

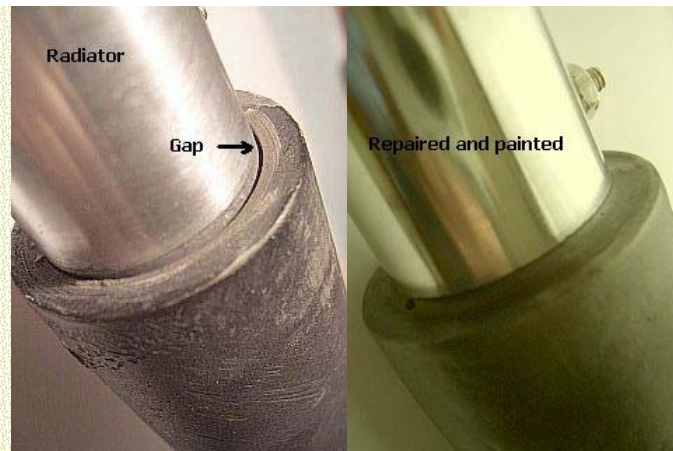
The antenna wobbled due to the gap caused by evaporation of the polyester. The tube was removed, the inside of the insulator applied with layers of 2 component polyester resin until a minimum variation of fit of the tube. Then I sanded the insulator for a perfect cylindrically curved shape and applied the last layer and placed the antenna back in the insulator. In fact the insulator was restructured to its original diameter.

I used a polyester repair set (for automobile) and applied the 2 component polyester resin with a brush. Eventually fill holes with fibreglass. The 2 component polyester resin can be used in combination with fibreglass mat and fibreglass thin film to fill holes in surfaces of steel, aluminium, wood, concrete and polyester. Polyester resin is elastic and resistant to chemicals and weather influences and is, after hardening only sand smooth mechanically.

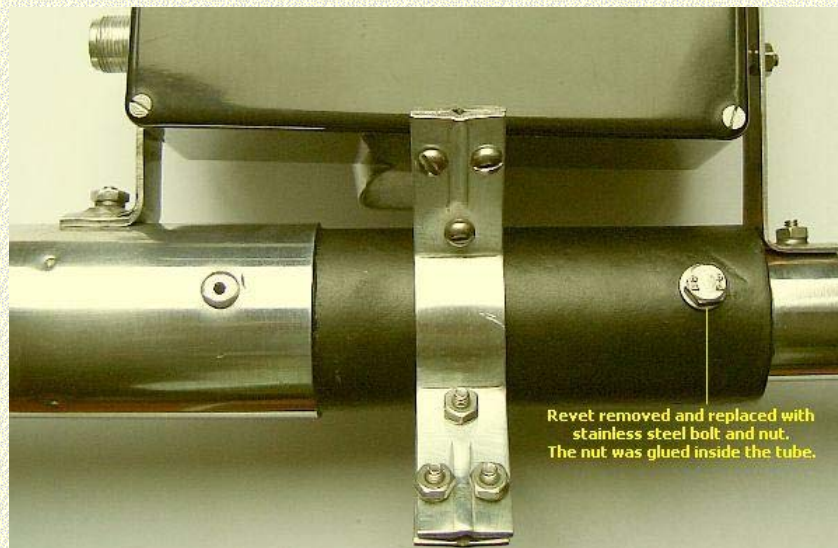
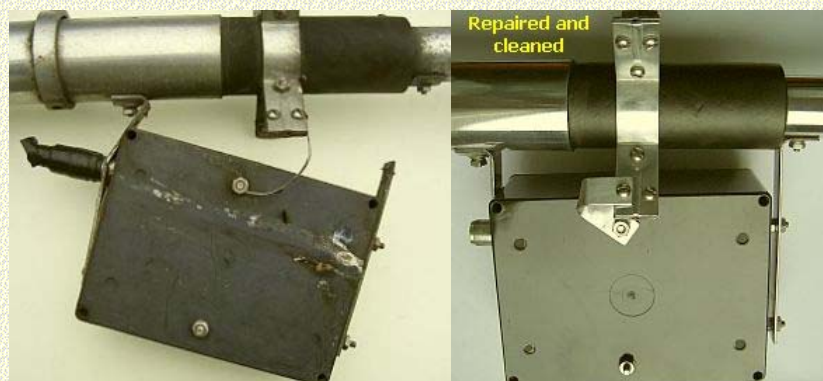
Due to the gap the antenna wobbled and one of the straps was broken.
